**DEPARTMENT OF TRANSPORTATION**

Contract #: 04-0120F4Cty: SF/ALA Rte: 80 PM: 13.2/13.9File #: 69.28**WELDING INSPECTION REPORT****Resident Engineer:** Pursell, Gary**Address:** 333 Burma Road**City:** Oakland, CA 94607**Report No:** WIR-002824**Date Inspected:** 02-Jun-2008**Project Name:** SAS Superstructure**OSM Arrival Time:** 2300**Prime Contractor:** American Bridge/Fluor Enterprises, a JV**OSM Departure Time:** 730**Contractor:** Zhenhua Port Machinery Company, Ltd (ZPMC), Changxing Island **Location:** Shanghai, China**CWI Name:** Xu Le feng**CWI Present:** Yes No**Inspected CWI report:** Yes No N/A**Rod Oven in Use:** Yes No N/A**Electrode to specification:** Yes No N/A**Weld Procedures Followed:** Yes No N/A**Qualified Welders:** Yes No N/A**Verified Joint Fit-up:** Yes No N/A**Approved Drawings:** Yes No N/A**Approved WPS:** Yes No N/A**Delayed / Cancelled:** Yes No N/A**Bridge No:** 34-0006**Component:** Caltrans OBG, Tower**Summary of Items Observed:**

**New Tower Bay 1**

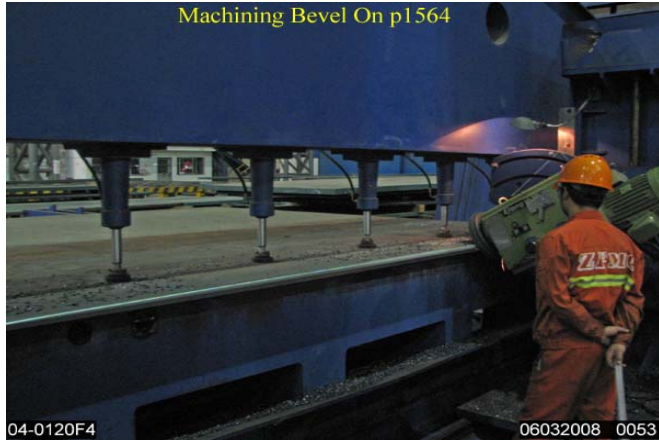
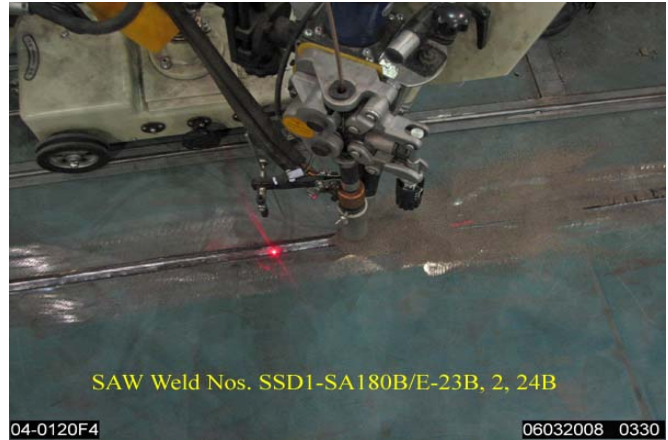
The Caltrans QA Inspector randomly observed the milling of weld bevel on Piece Mark p1564.

All above observations appeared to meet the requirements of the job specifications.
